ARRIS Lander X3 release 1

ARRIS Lander X3 release 2 (Tube fixation modification)

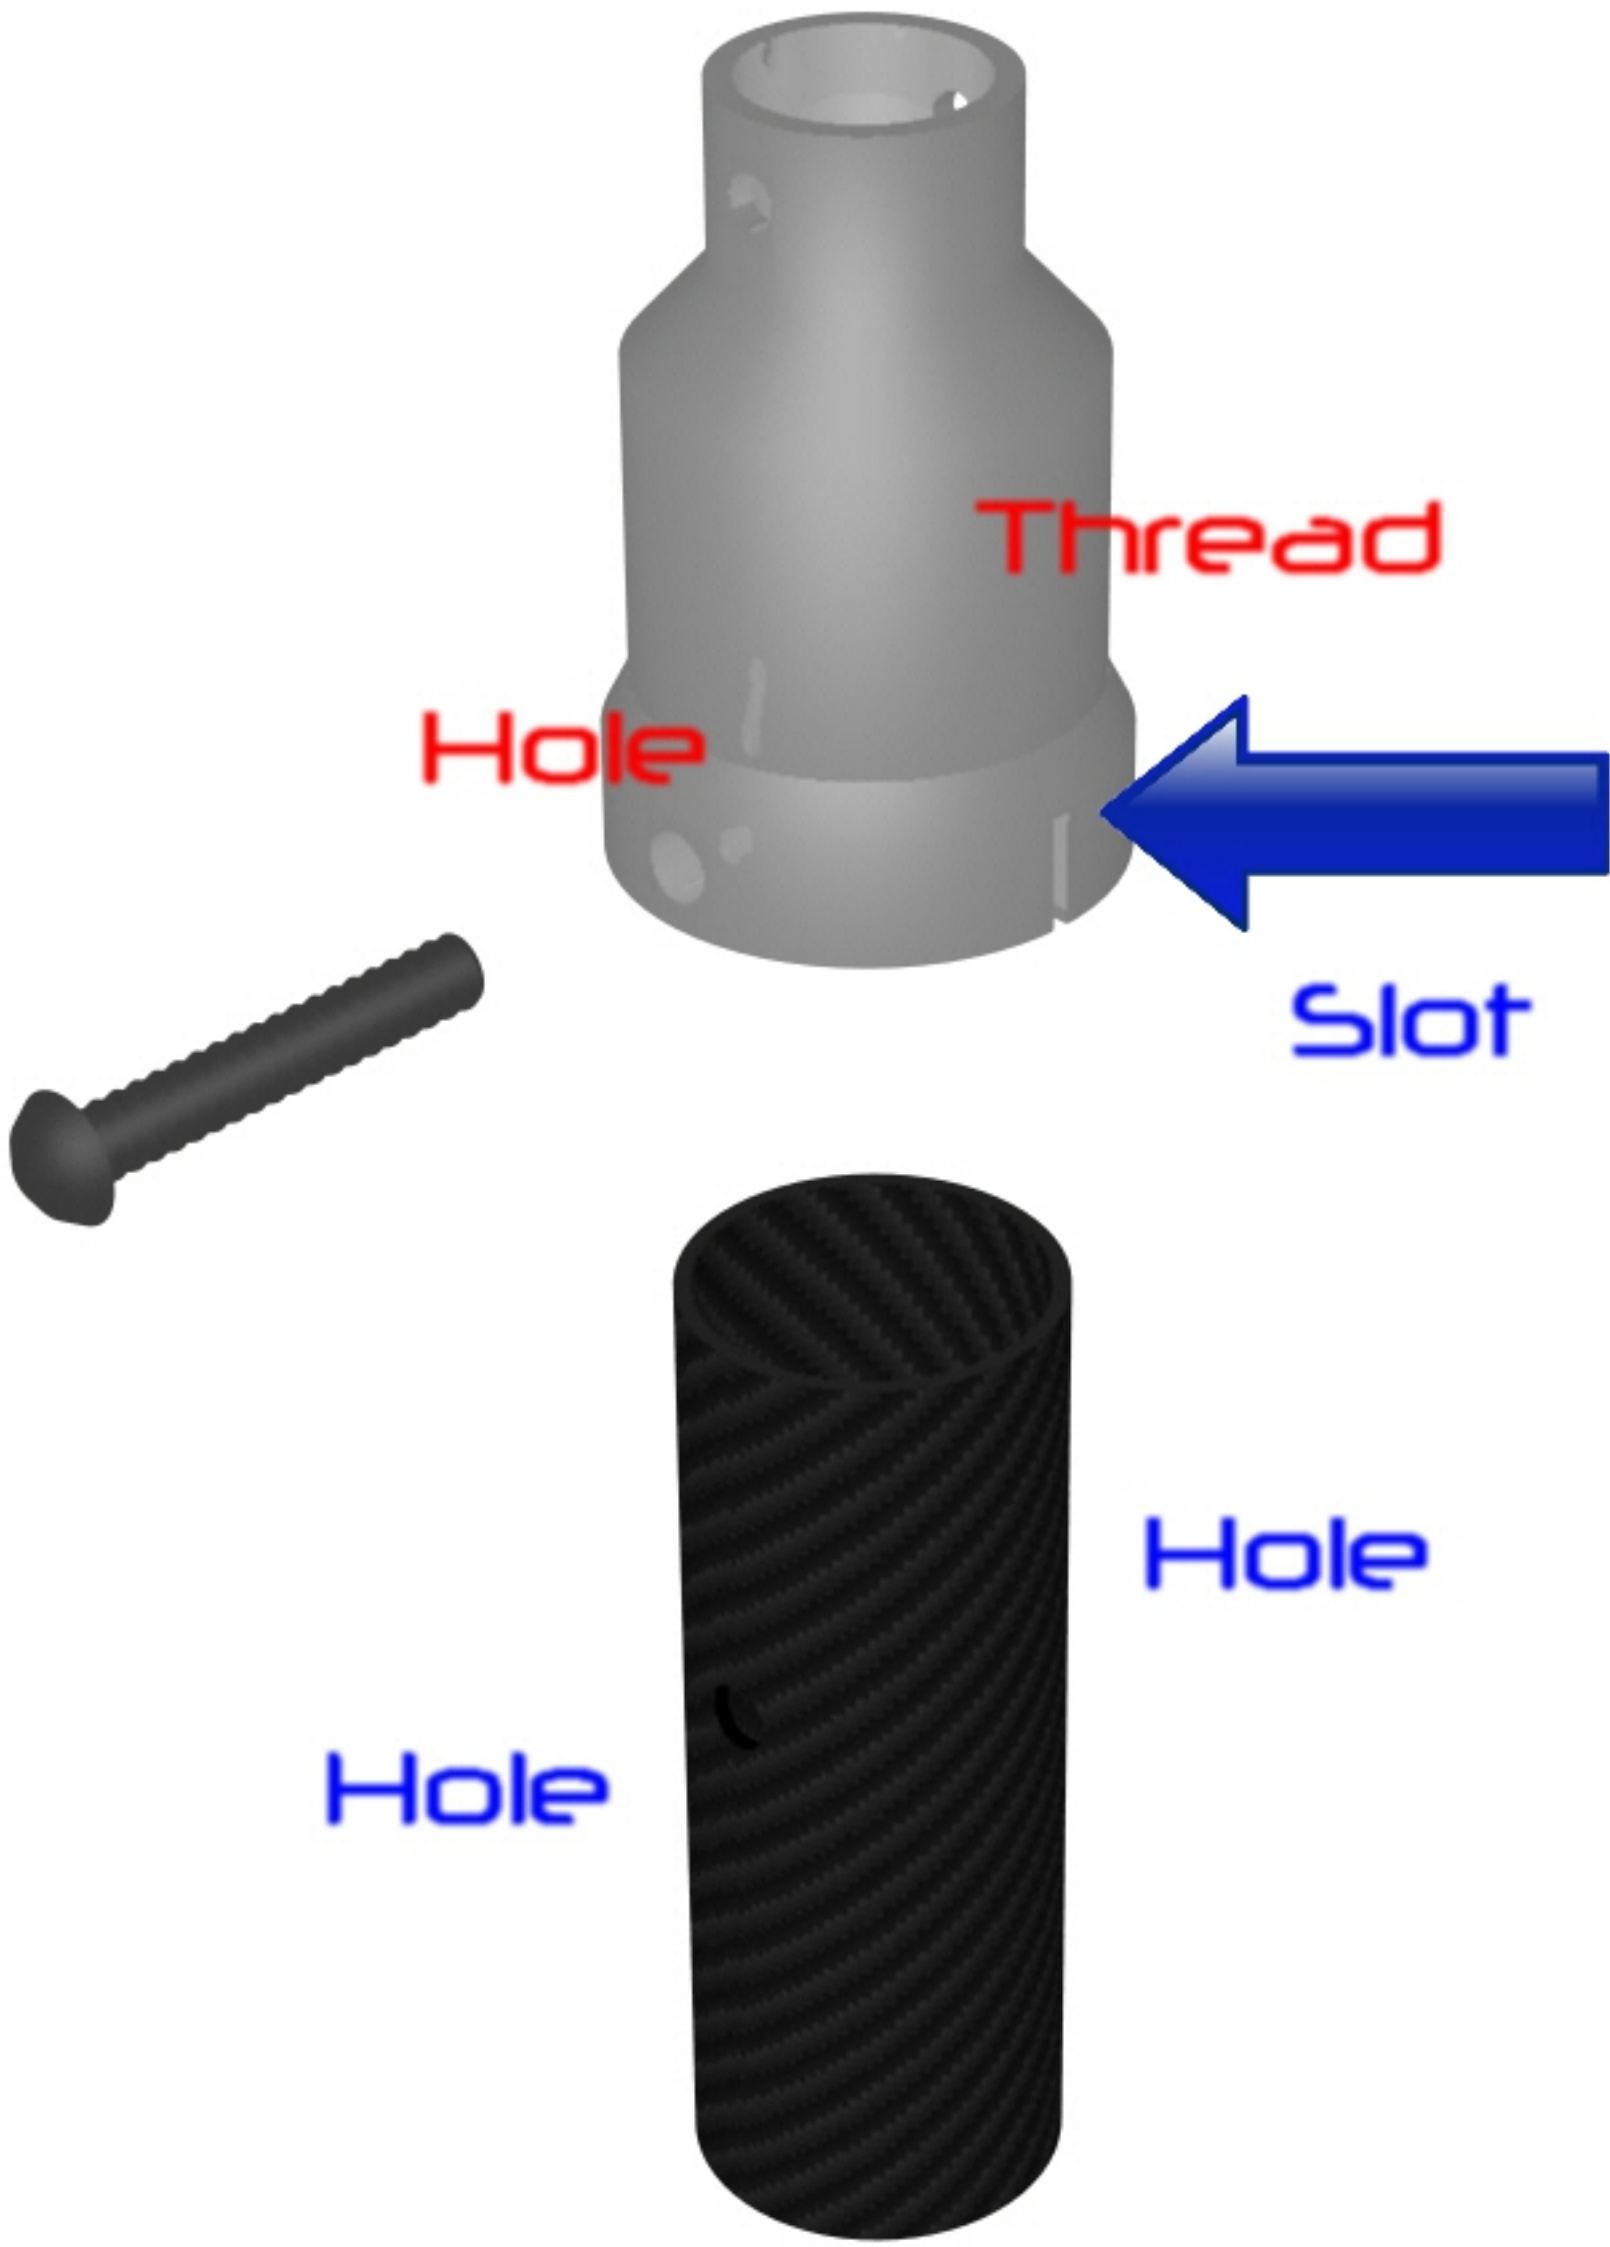
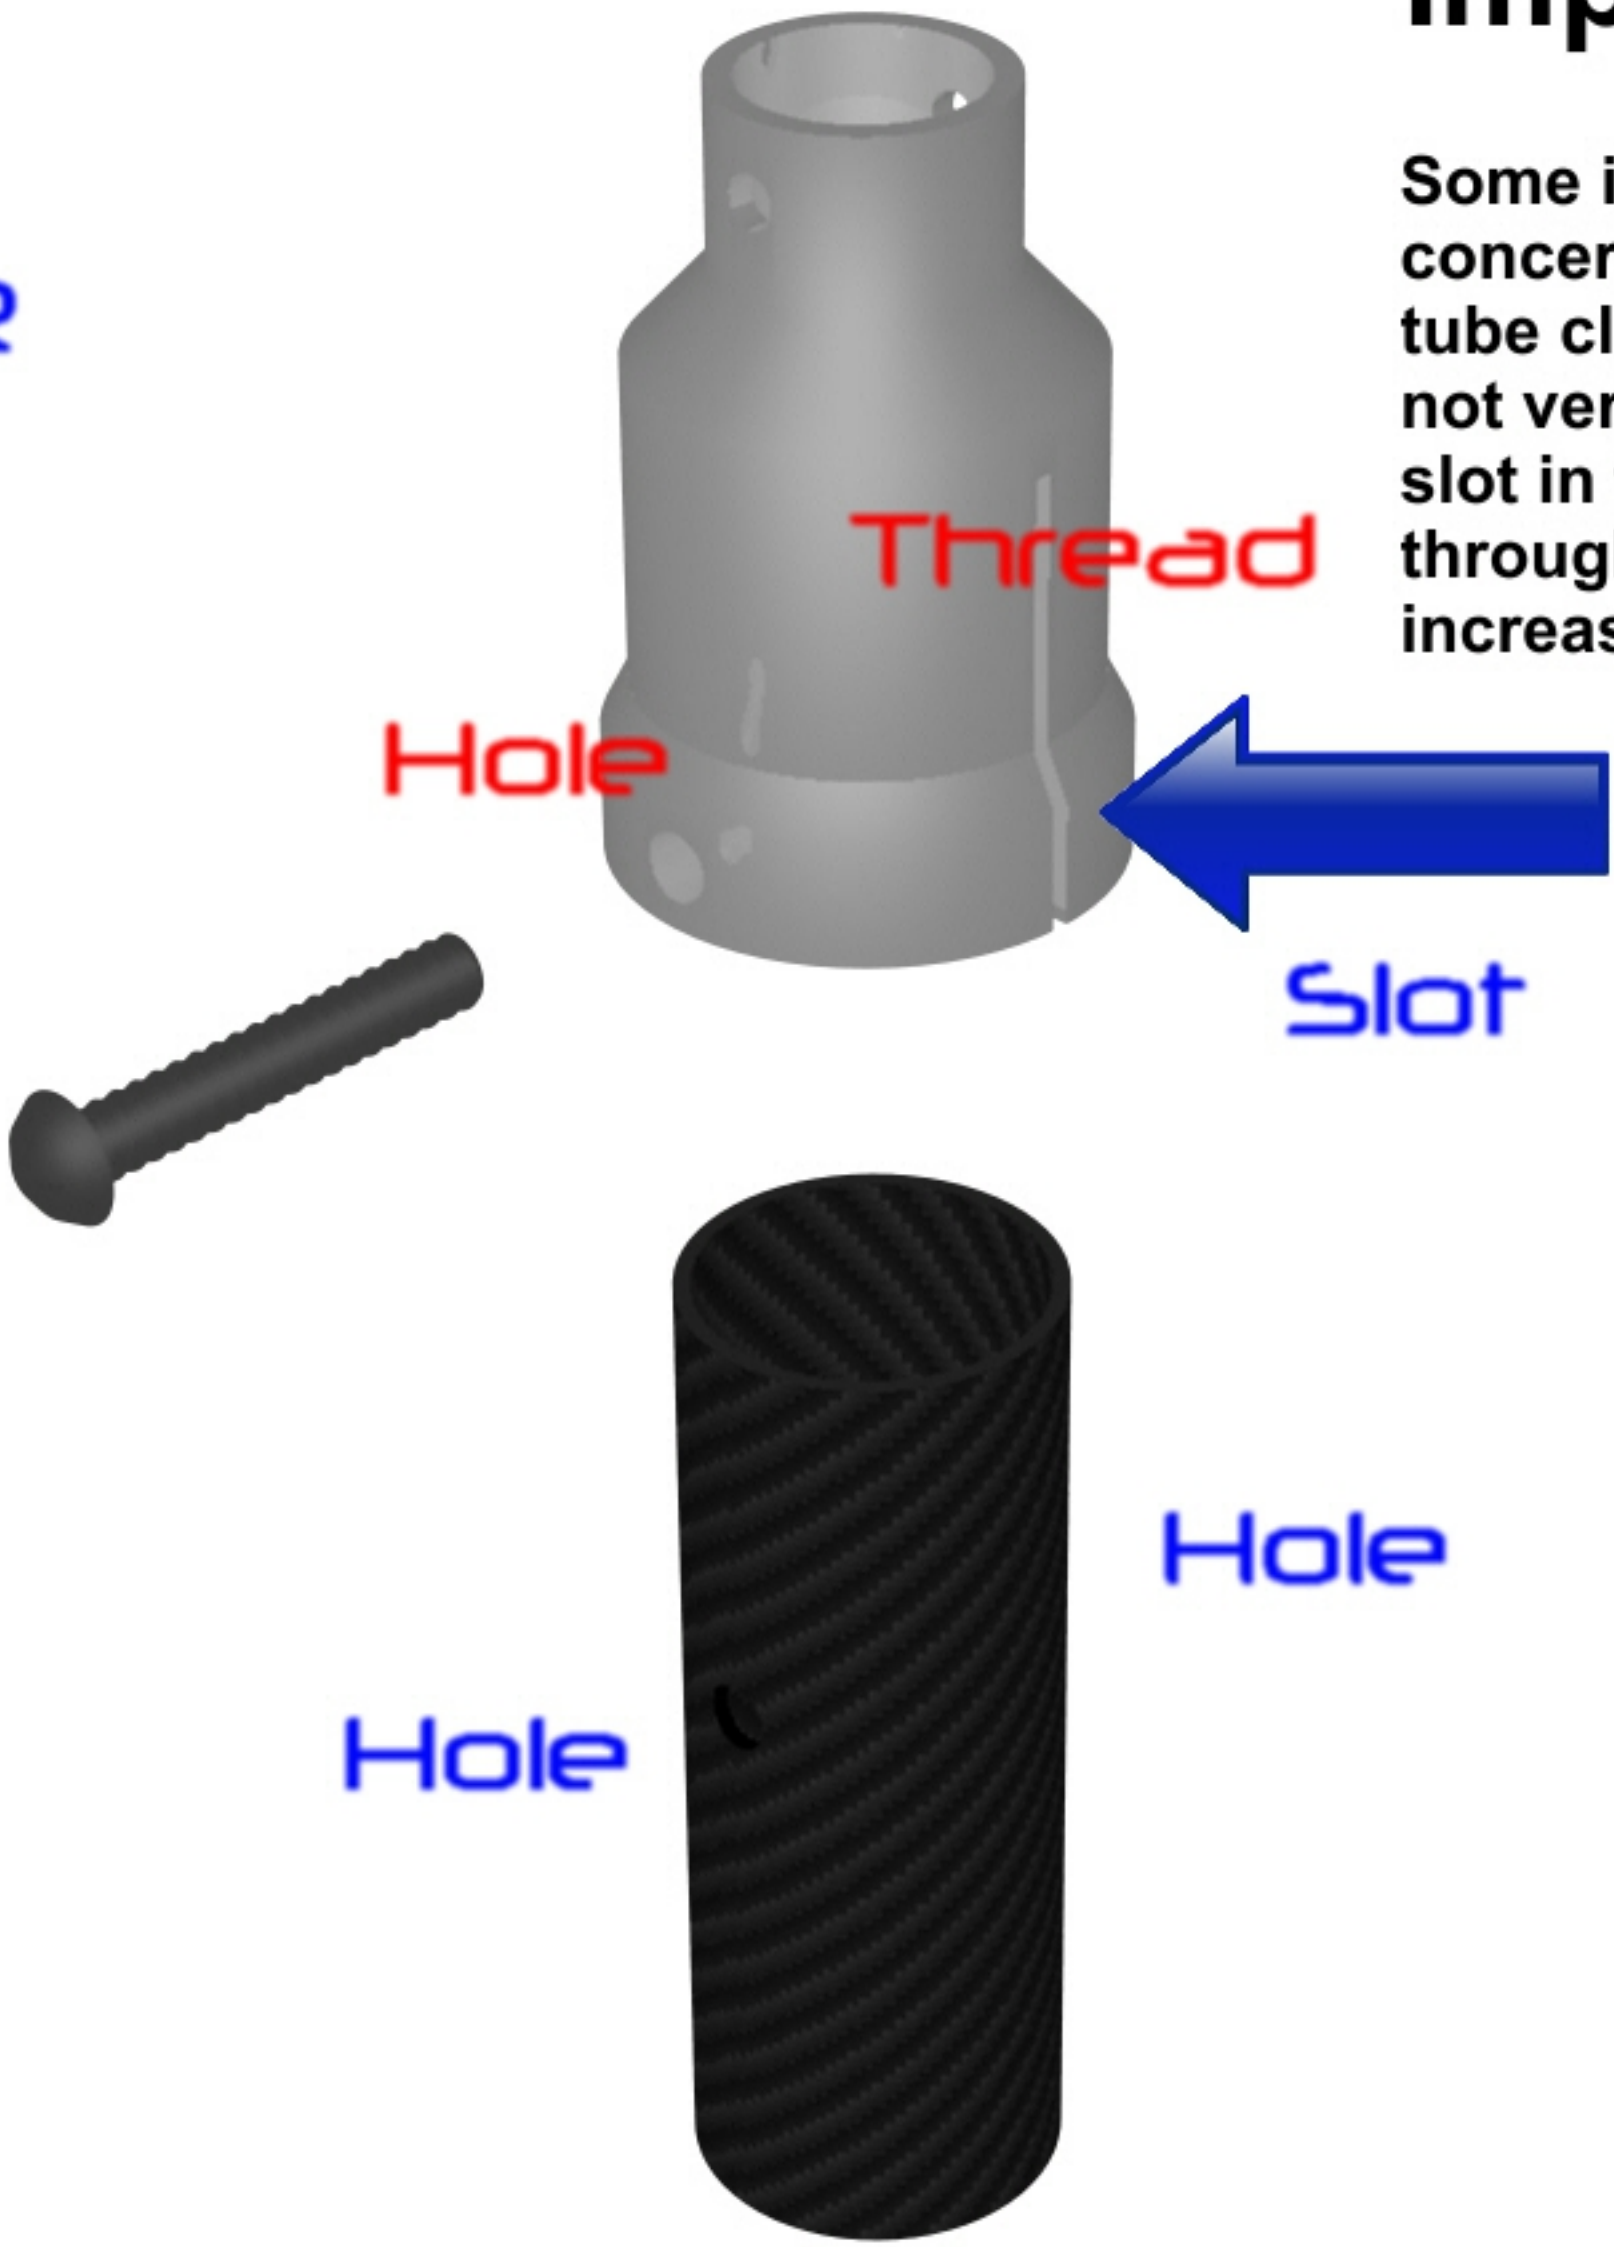
Some improvements could be made concerning the tube fixation. Indeed the tube clamping system in the servo unit is not very effective. Here they could mill a slot in the metal portion and drill holes through the tube, which would greatly increase the stiffness of the binding.
